Building 62, Bankstown Aerodrome NSW

PROPERTY CONDITION REPORT

5/11/2024

PREPARED FOR
BANKSTOWN AIRPORT PTY LIMITED

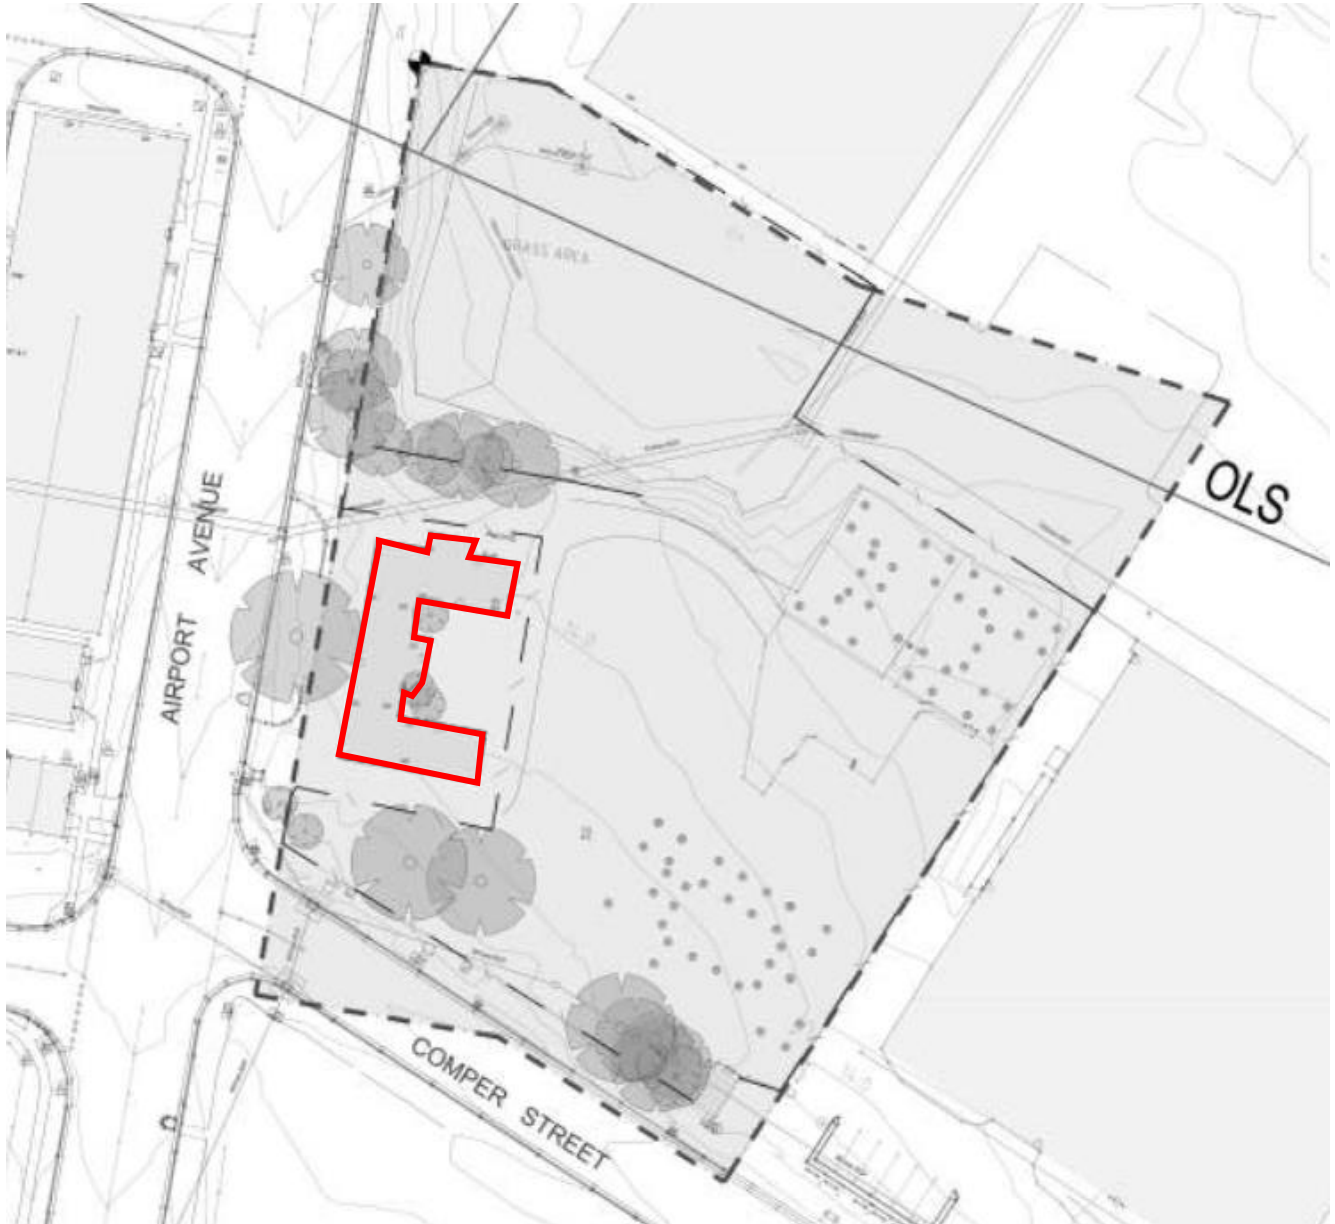
Based on our visual inspection, all parts of the building are generally considered to be in poor condition – refer to red mark-up in floor plan below.

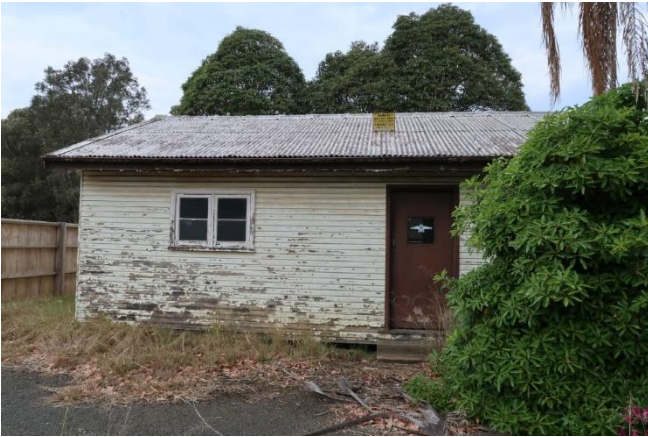
Roof covering	Poor	The roof is covered with profiled asbestos sheeting. The roof sheeting is in poor condition and beyond its economic life expectancy with significant water ingress damage noted internally.
Roof plumbing	Poor	Eaves guttering installed around the perimeter of the building. The guttering is severely corroded throughout.
External walls	Poor	External walls are clad with painted weatherboard. Timber rot and deteriorated finishes noted to the cladding.

Asbestos roof sheeting and deteriorated cladding

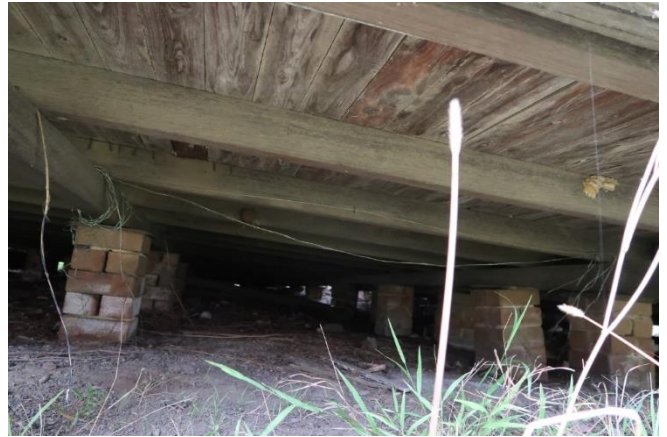
BUILDING ELEMENT	CONDITION	COMMENTS
Exterior & Structural		
Substructure / foundations	Poor / Fair	Masonry brick piers observed from the perimeter of the building. Generally appeared to be in fair to poor condition with deteriorated mortar beds and instances of 'leaning' piers.
Superstructure	Poor / Fair	Timber framed superstructure comprising timber framed external walls and suspended timber floor. The suspended timber floor was observed from the building perimeter and the wall framing was observed where the external and internal wall linings has been damaged or rotted. Localised rot and damp timber framing were noted in various locations.
Roof structure	Poor / Fair	Limited access was available to inspect the timber framed roof structure internally where the ceilings have collapsed due to water ingress. No significant evidence of rot was identified to the timber roof framing, however damp timbers were evident due to water ingress.

Deteriorated mortar beds and 'leaning' pier

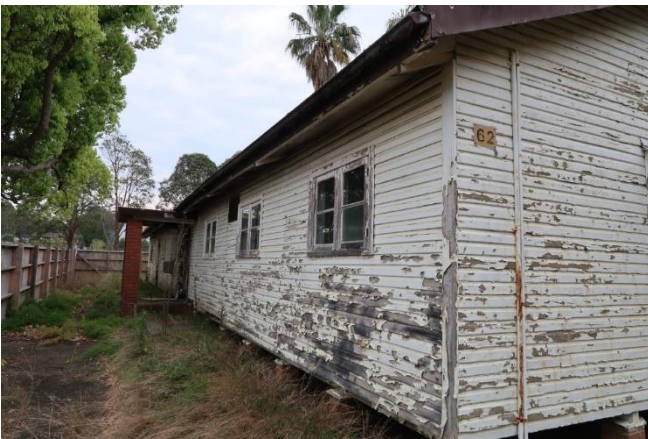
Building fabric in poor condition

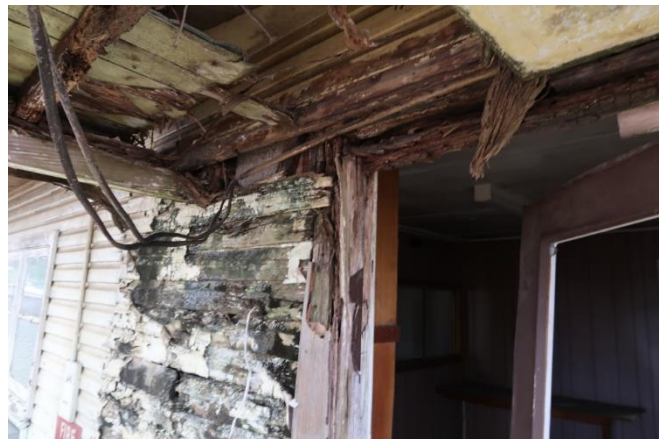
Rotted timber frame

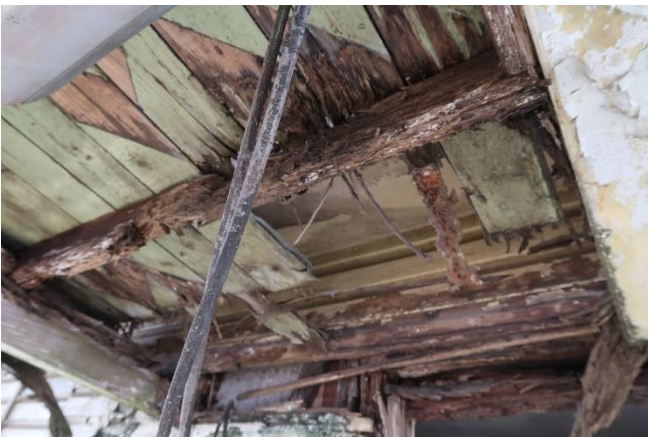
Rotted timber frame

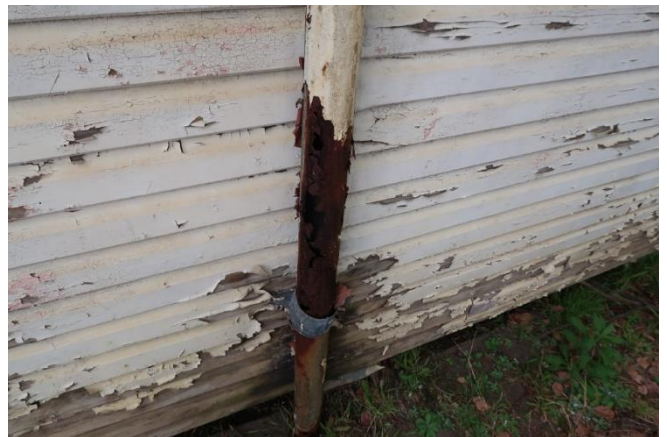
Corroded downpipe

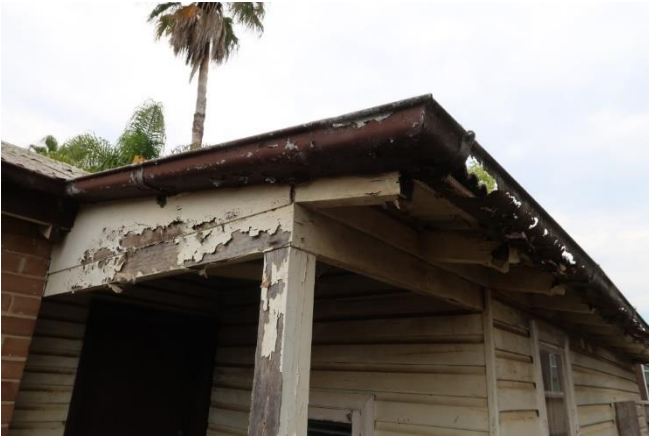
Corroded guttering

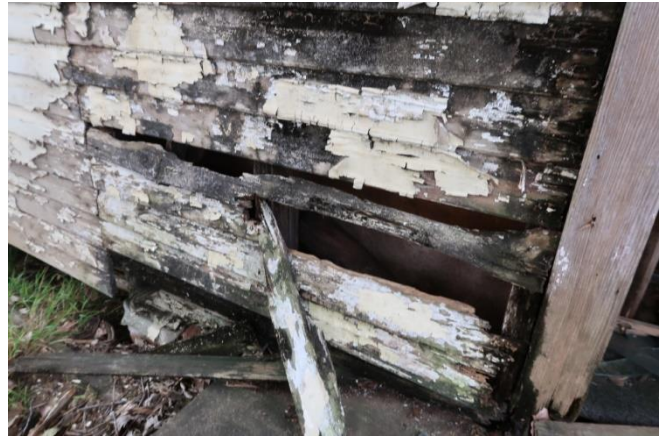
Rotted timber cladding

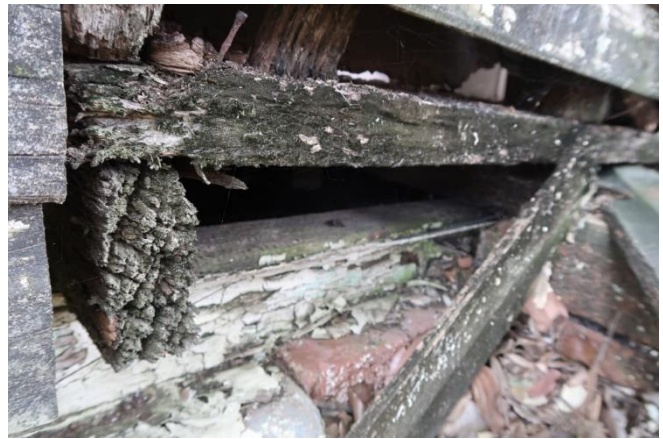
Rotted timber frame

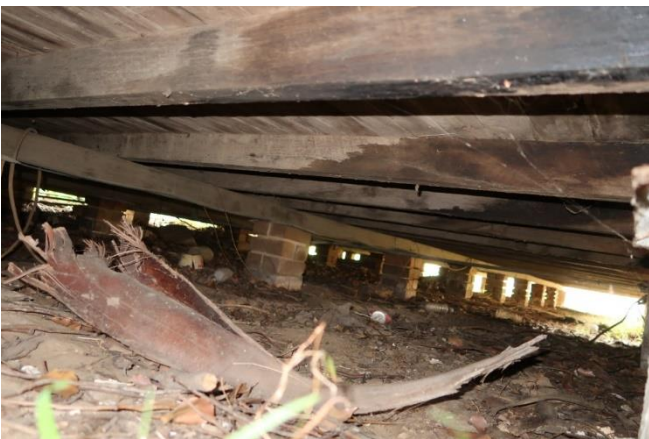
Damp timbers to suspended floor structure

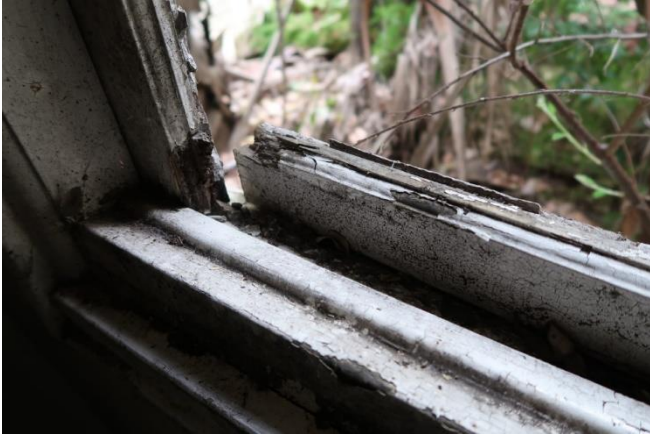
BUILDING ELEMENT	CONDITION	COMMENTS
External windows	Poor	Timber framed single glazed units. Timber rot and deteriorated finishes throughout the window frames and evidence of water ingress. Cracked, damaged and missing glazing throughout.
External doors	Poor	Painted timber doors to the façade are in poor condition and at the end of their economic life expectancy.
Internal Fabric & Finishes		
Generally	Poor	The building is derelict and its last known use was as an office / training facility. Finishes throughout are in poor condition and the building is not fit for occupation.
Internal walls & screens	Poor	Internal walls are timber framed partitions lined with a fibro softboard. Generally in poor condition with localised impact damages throughout.
Internal finishes	Poor	Internal finishes are in poor decorative order throughout.
Floor finishes	Poor	Carpet and vinyl floor coverings are in poor condition throughout.

Window frame in poor condition

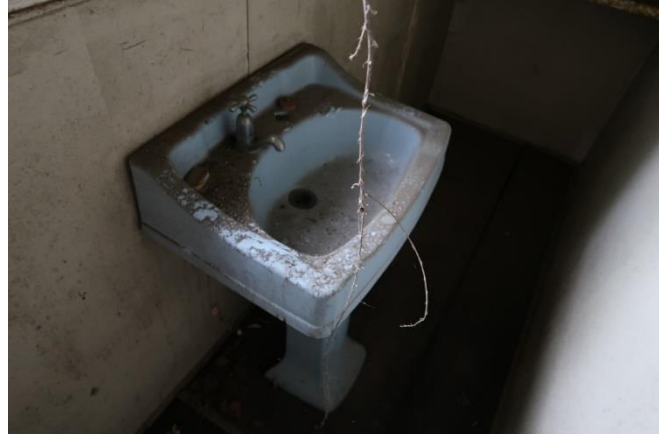
Amenities fixtures in poor condition

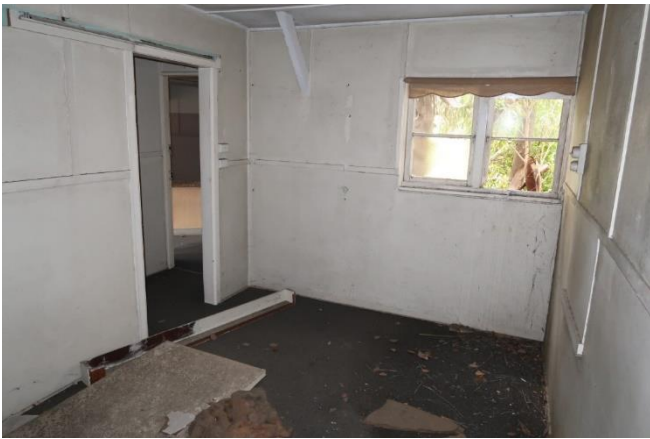
Interior finishes in poor condition

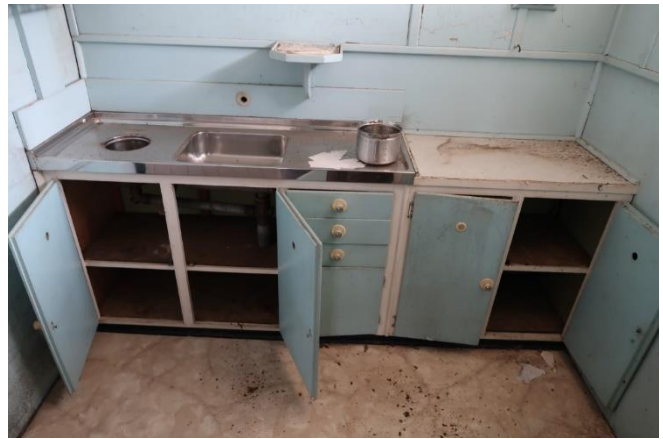
Kitchen cabinetry in poor condition

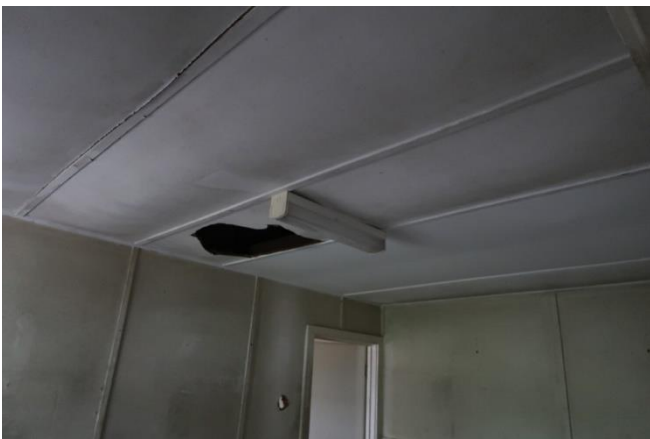
Water damaged ceiling

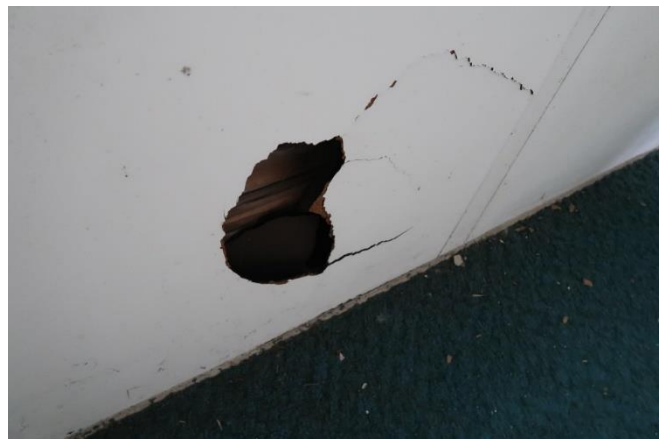
Impact damaged wall

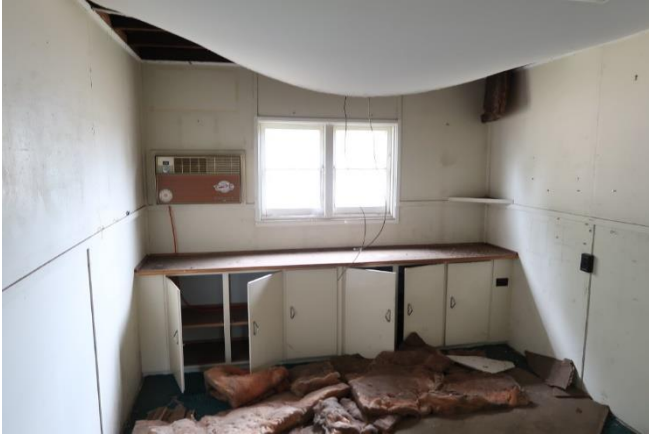
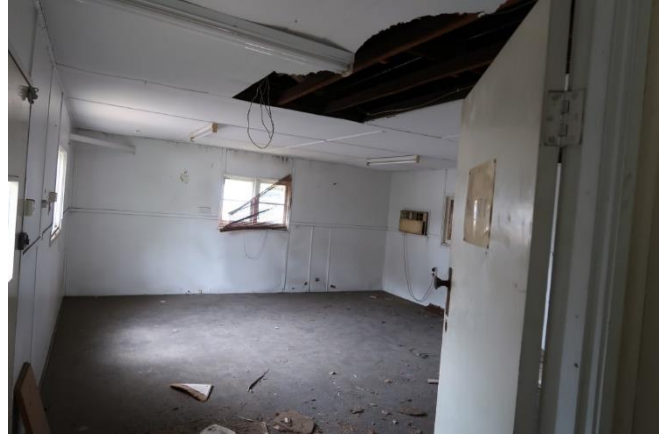
Ceilings	Poor	Ceilings are lined with a painted fibro softboard. Ceilings are in poor condition with water ingress damage and risk of further collapse in various locations.
Fixtures	Poor	Bathroom and kitchen fixtures are in poor condition and have exceeded their serviceable life.
Services		
Mechanical	Poor	Wall and window air cooled A/C units appear obsolete and well beyond their economic life expectancy.
Electrical	Poor	Main Distribution Board (MDB) old style surface mounted lights and communications system all appear in poor condition and beyond their economic life expectancy.
Fire		No fire protection services installed to the building.
Hydraulic	Poor	Hydraulic infrastructure and sanitary fixtures are all in poor condition and beyond their economic life expectancy.
External Areas		
Grounds & landscaping	Poor / Fair	Grass and weed growth around the immediate external areas which are enclosed with timber framed construction hoarding, offset approx 2-4m from the perimeter of the building. Maintenance appears fair to poor.

Partially collapsed ceiling

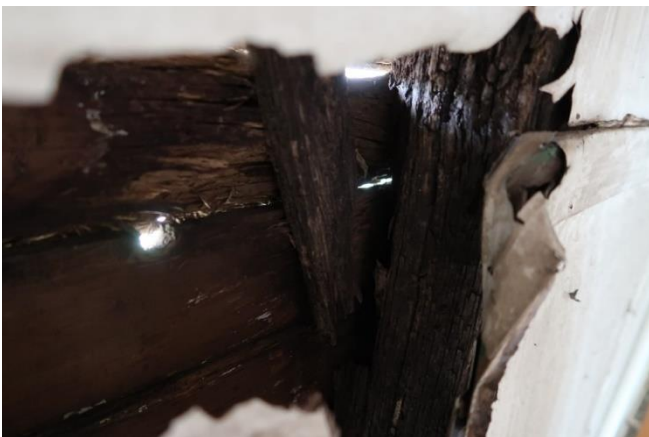
Rotted timber frame
