Building 62, Bankstown Aerodrome NSW

PROPERTY CONDITION REPORT

5/11/2024

PREPARED FOR
BANKSTOWN AIRPORT PTY LIMITED

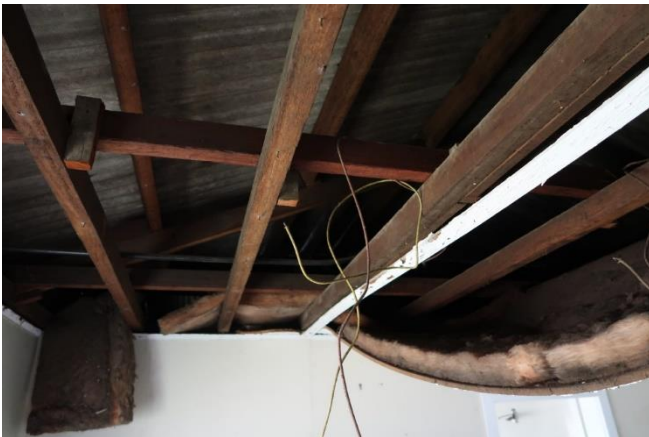
BUILDING ELEMENT	CONDITION	COMMENTS
Exterior & Structural		
Substructure / foundations	Poor / Fair	Masonry brick piers observed from the perimeter of the building. Generally appeared to be in fair to poor condition with deteriorated mortar beds and instances of 'leaning' piers.
Superstructure	Poor / Fair	Timber framed superstructure comprising timber framed external walls and suspended timber floor. The suspended timber floor was observed from the building perimeter and the wall framing was observed where the external and internal wall linings has been damaged or rotted. Localised rot and damp timber framing were noted in various locations.
Roof structure	Poor / Fair	Limited access was available to inspect the timber framed roof structure internally where the ceilings have collapsed due to water ingress. No significant evidence of rot was identified to the timber roof framing, however damp timbers were evident due to water ingress.

Timber framed roof structure
